**FEDERAL ON-SCENE COORDINATOR'S
REPORT
for
ALIQUIPPA TIN MILL SITE
ALIQUIPPA, BEAVER COUNTY, PENNSYLVANIA
May 27, 2017 to June 30, 2020**

UNITED STATES
ENVIRONMENTAL PROTECTION AGENCY
REGION III
WHEELING, WEST VIRGINIA

**Federal On-Scene Coordinator's Report
Aliquippa Tin Mill Site**

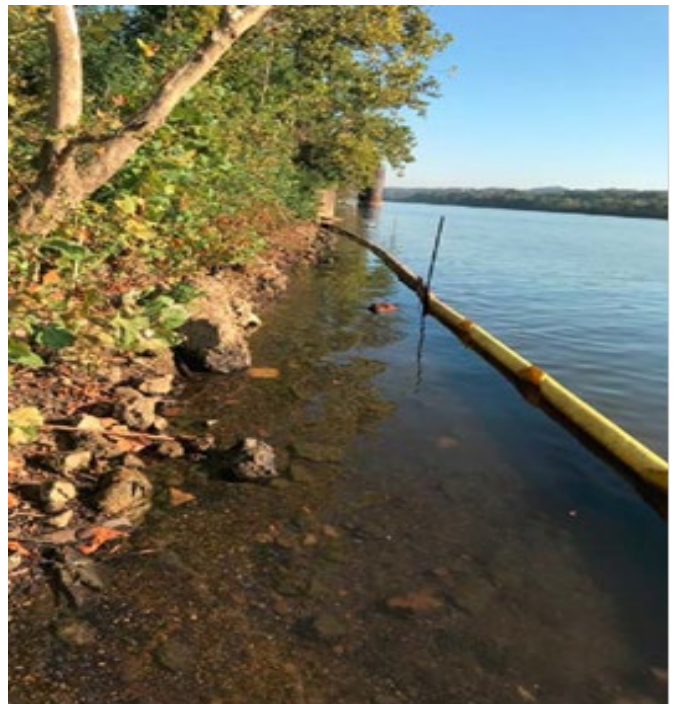
Photolog 126: Facing N/NE. New orientation of harbor boom coming into contact with shore at 0' marker. 09/25/19. (START photo IMG_0354).

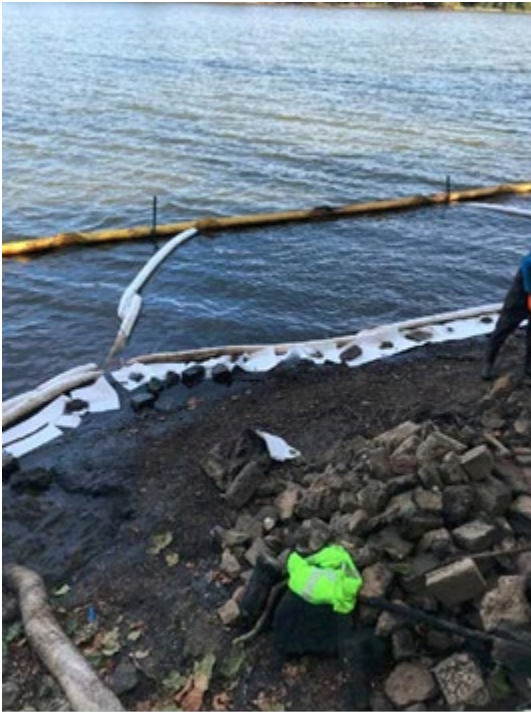
Photolog 127: Facing East. Pig mats lining river bank. 09/25/19. (START photo IMG_0358).

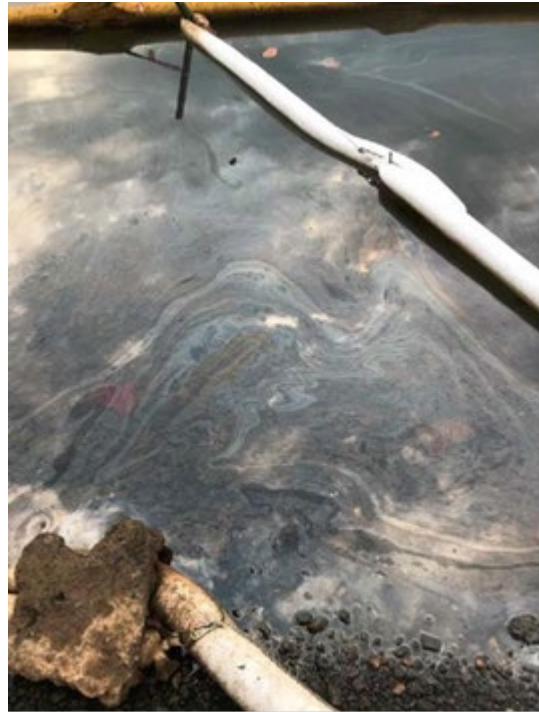
Photolog 128: Facing Down. Silver sheen on water around 280' marker. 09/26/19. (START photo IMG_0361).

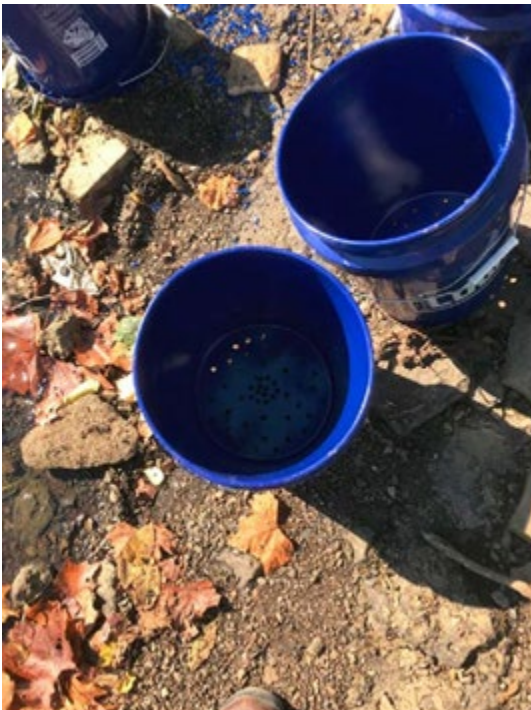
Photolog 129: Facing Down. Buckets used for transport of rock and sediment to Super Sacks. 09/27/19. (START photo IMG_0366)

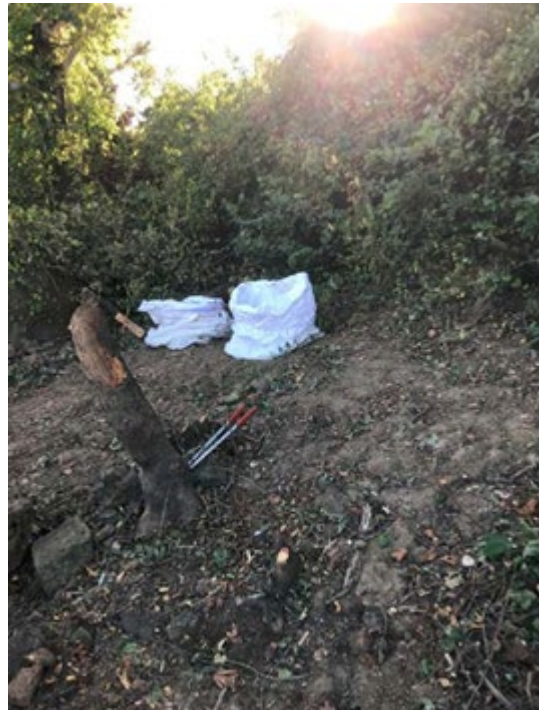
Photolog 130: Facing SW. Super Sacks used for rock and sediment disposal. 09/27/19. (START photo IMG_0368)

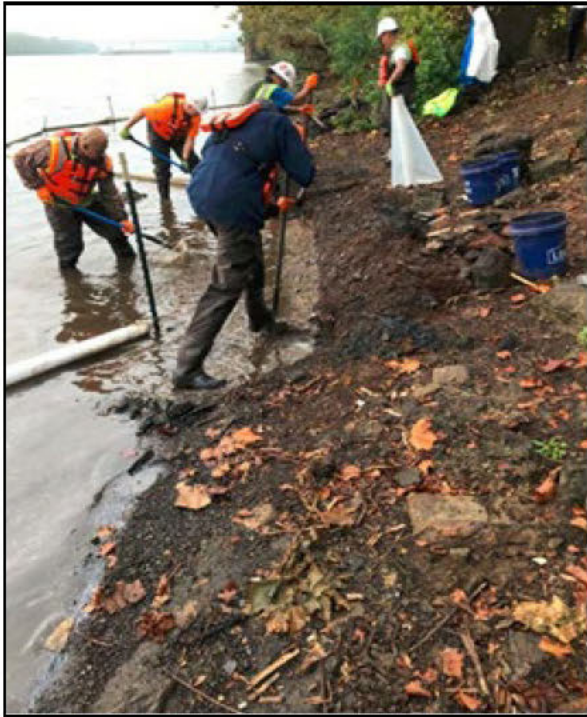
Photolog 130: Facing S/SW. ERRS digging trench along the 280' - 300' interval. 09/30/19. (START photo IMG_0370)

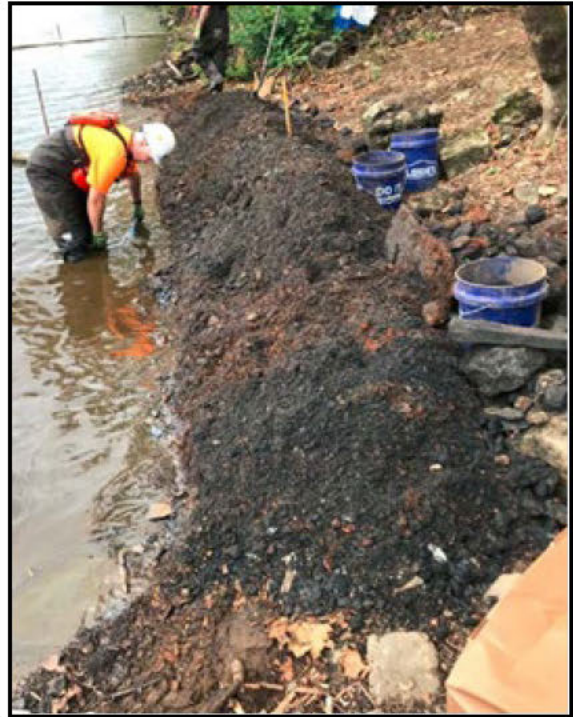
Photolog 131: Facing S/SW. Rocks and sediment piled up from digging the trench. 09/30/19. (START photo IMG_0371)

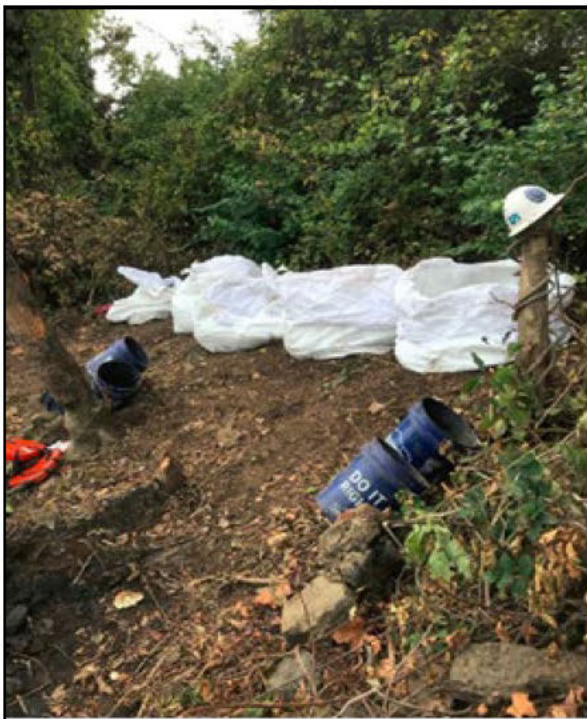
Photolog 132: Facing S/SE. Two filled Super Sacks and a third, partially full Super Sack. 09/30/19. (START photo IMG_0373)

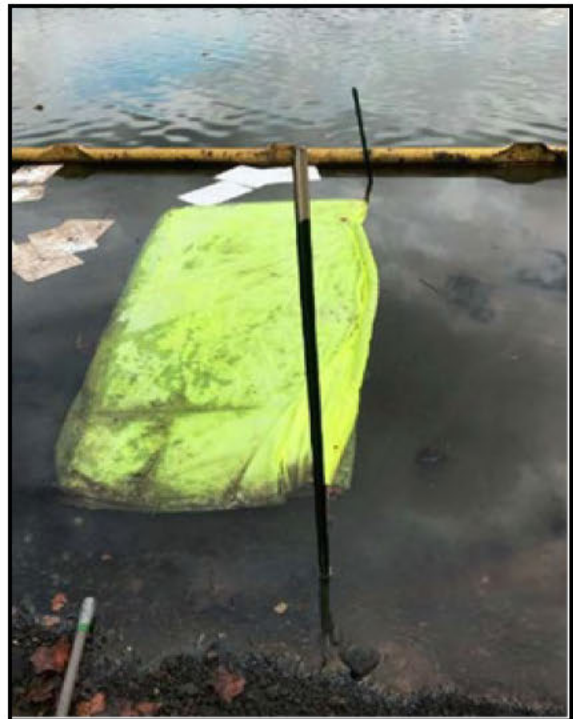
Photolog 133: Facing E. 5' x 10' Mycler Versamat laid out in the water and secured at the 260' mark. 09/30/19. (START photo IMG_0374)

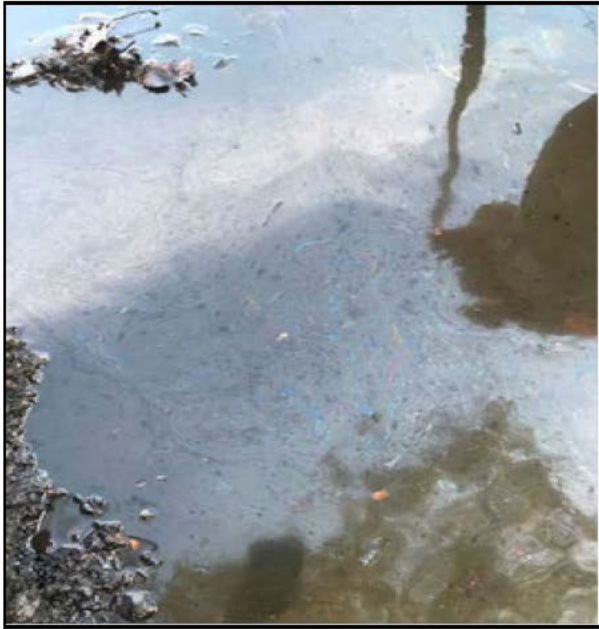
Photolog 134: Facing Down. Visible dark spots of oil in water around the 240' marker. Dark spots due to dredging of sediment to form trench. 10/01/19. (START photo IMG_0382)

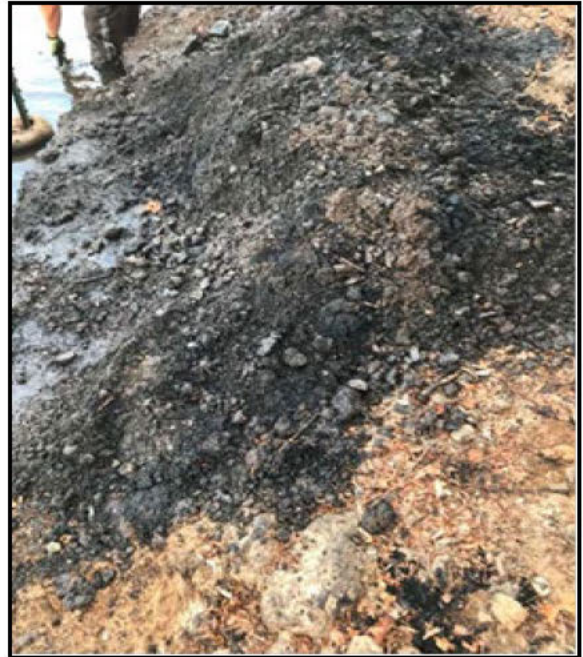
Photolog 135: Facing S/SE. Mound of dark/stained sediment dredged from below water's surface around the 240' marker. 10/01/19. (START photo IMG_0384)

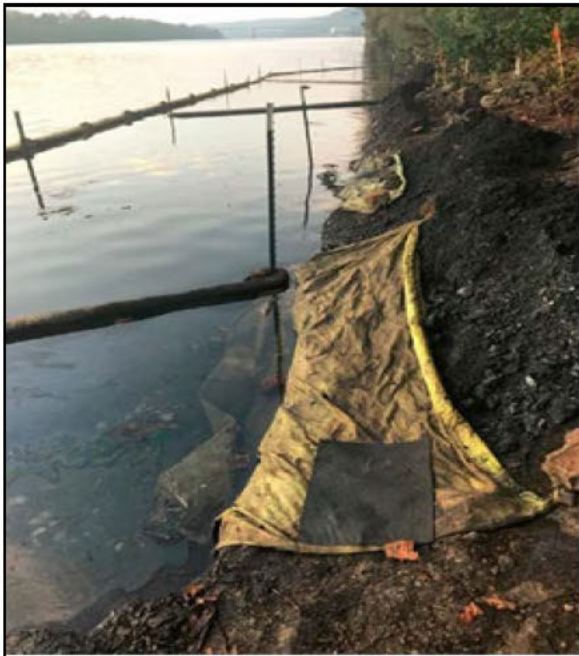
Photolog 136: Facing South. Results of Versmats used at interval 230'-240'. 10/02/19. (START photo IMG_1001)

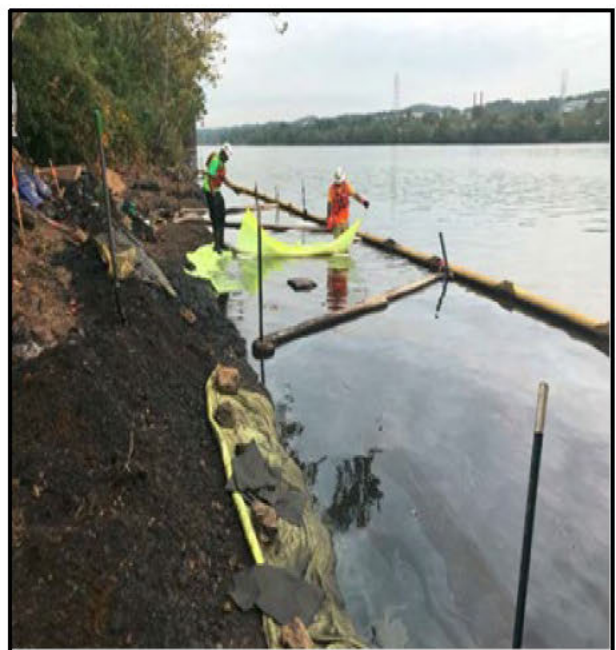
Photolog 137: Facing NE. ERRS laying out new Versmats and skimming the surface of the water to collect rainbow sheen. 10/02/19. (START photo IMG_1002)

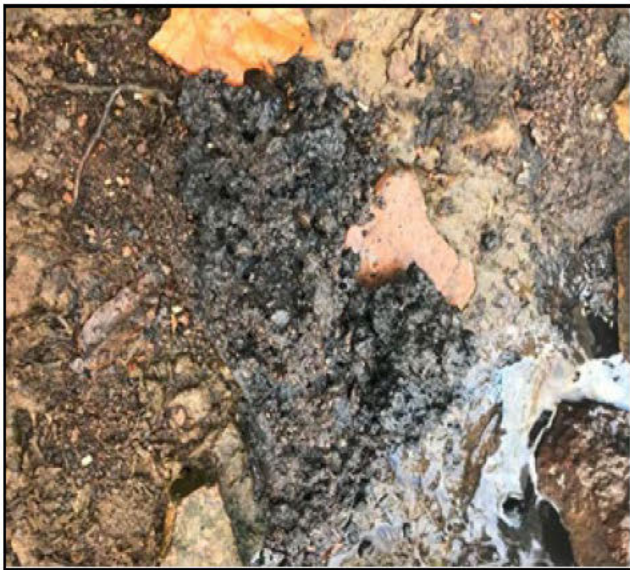
Photolog 140: Facing Down. Oil saturated sediment removed from 30'-60' interval. 10/02/19. (START photo IMG_1009)

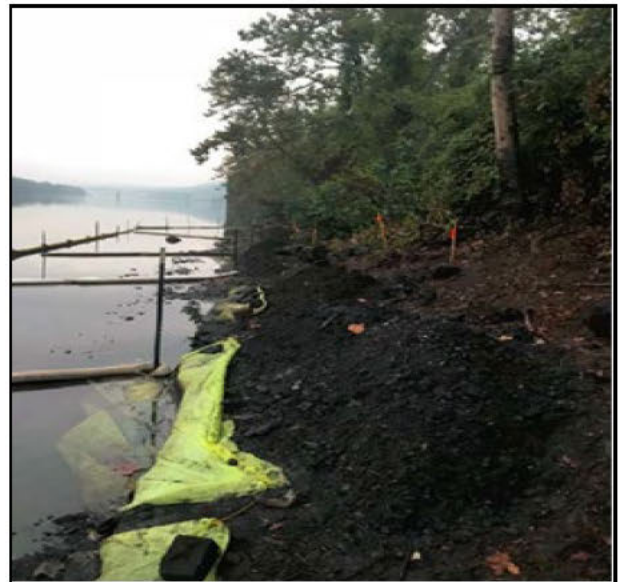
Photolog 141: Facing South. Sediment removed from 225'-300' and staged for vacuum truck. 10/02/19. (START photo IMG_1013)

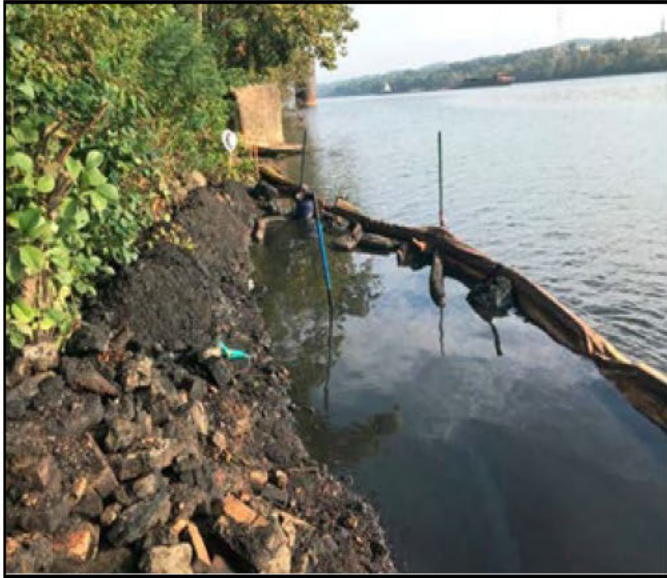
Photolog 142: Facing North. Sediment removed from 30'-60' interval and staged for vacuum truck. 10/03/19. (START photo IMG_1014)

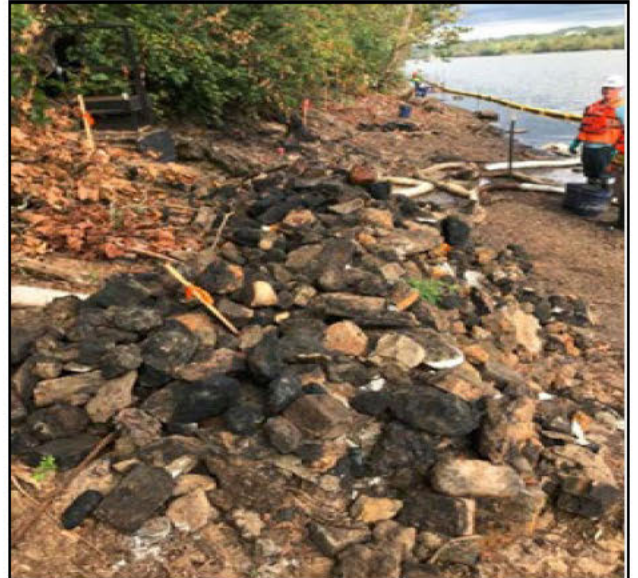
Photolog 143: Facing North. Stained rocks and bricks staged on bank near outfall at 210'-230' interval. 10/04/19. (START photo IMG_1019)

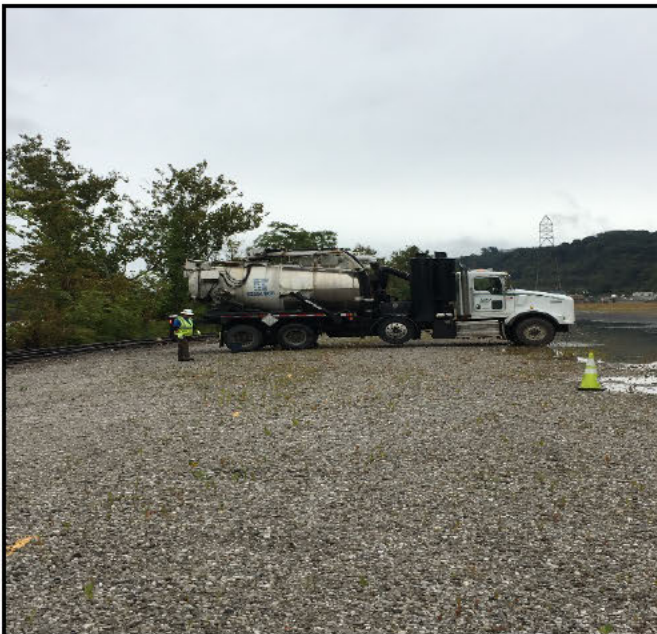
Photolog 144: Vacuum Truck being utilized to remove excavated sediments from the riverbank. 10/7/19. (EPA photo IMG_0611)

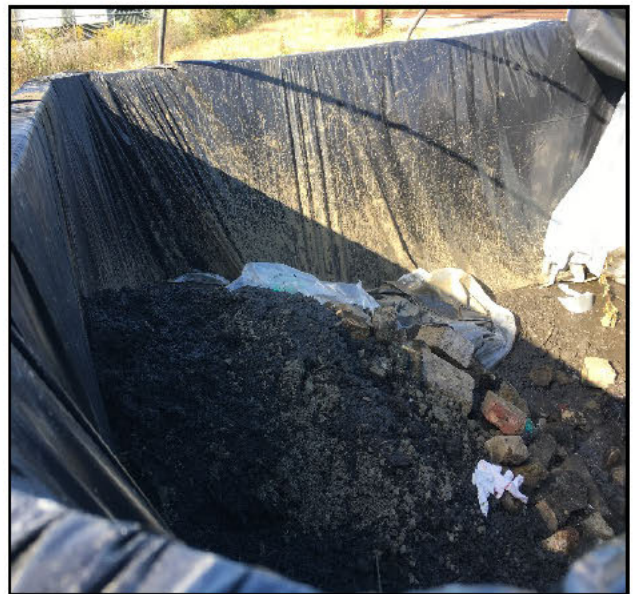
Photolog 145: Small amount of sediments removed using the Vacuum Truck. Sediments too wet and clogged hoses. 10/7/19. (EPA photo IMG_0613.jpg)

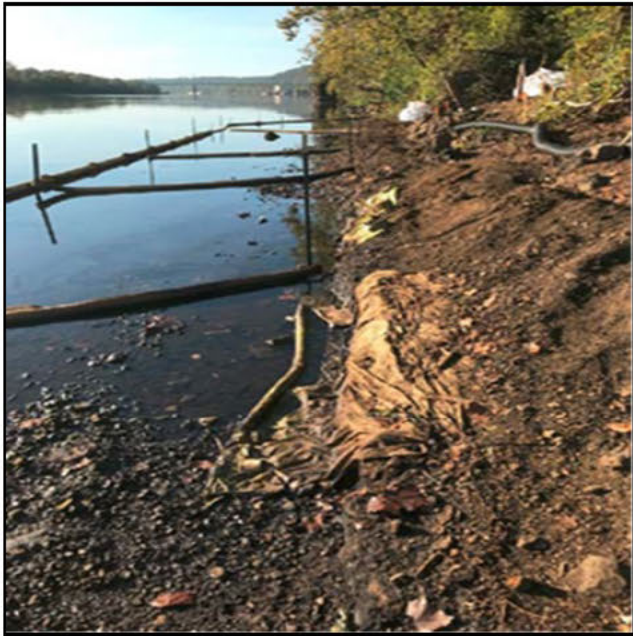
Photolog 146: Facing S/SE. View of riverbank where sediment was dredged and removed. 10/10/19. (START photo IMG_0385)

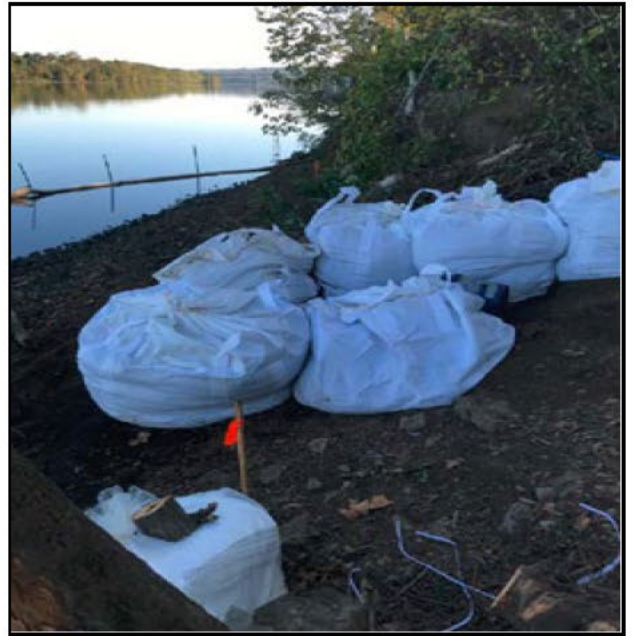
Photolog 147: Facing S/SE. Five Super Sacks that are filled with soil. Four are full and one is approximately 25% full. 10/10/19. (START photo IMG_0392)

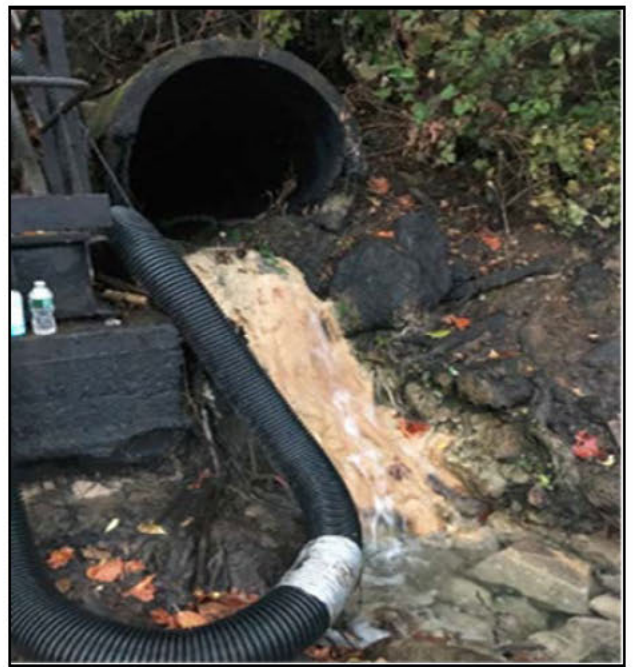
Photolog 149: Facing West. Amount of drainage water flowing from outfall morning of 10/17/19. (START photo IMG_1025)

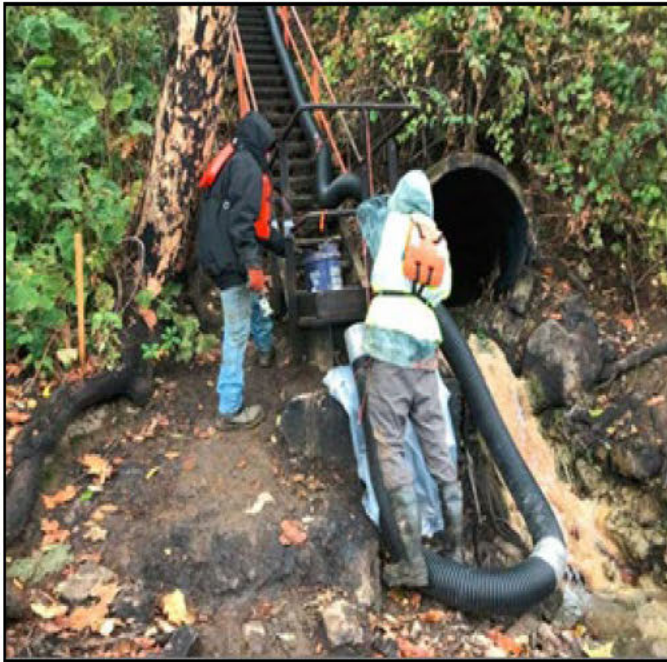
Photolog 150: Facing West. ERRS personnel scraping off tar-like material from stairway. 10/17/19. (START photo IMG_1026)

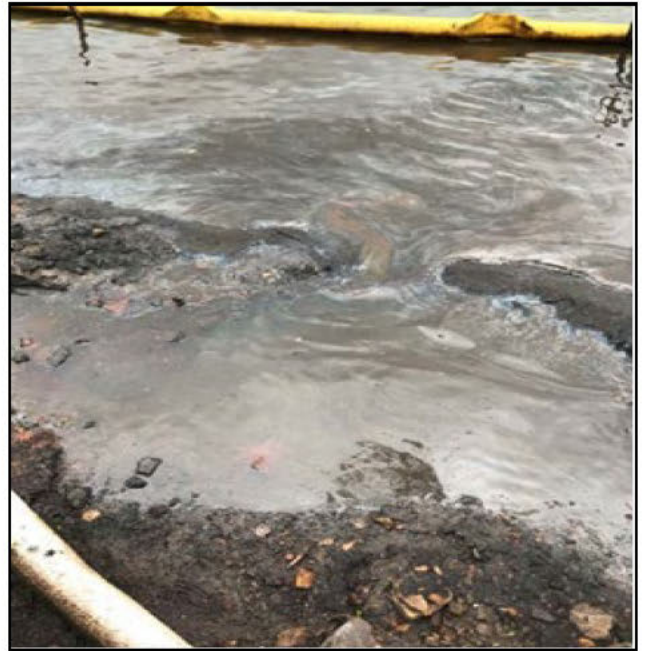
Photolog 151: Facing Down. Large amount of rainbow sheen located on water between outfall and 190' marker. 10/17/19. (START photo IMG_1030)

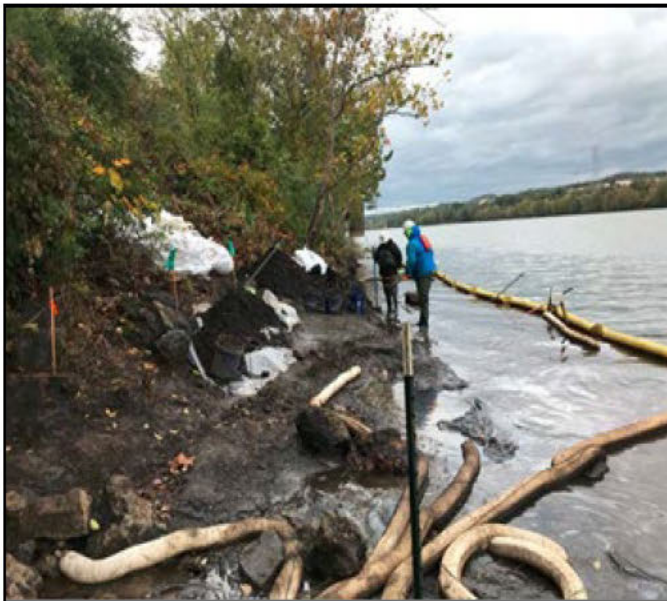
Photolog 152: Facing North. ERRS removing sediment/soil below staged Super Sacks at 190' marker. 10/17/19. (START photo IMG_1027)

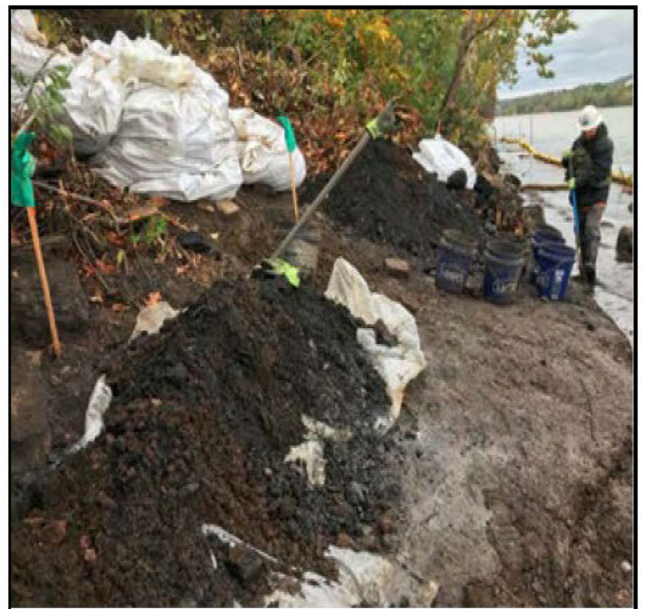
Photolog 153: Facing Down. Staged sediment/soil and stained rock material between 170'-200' interval. 10/17/19. (START photo IMG_1029)

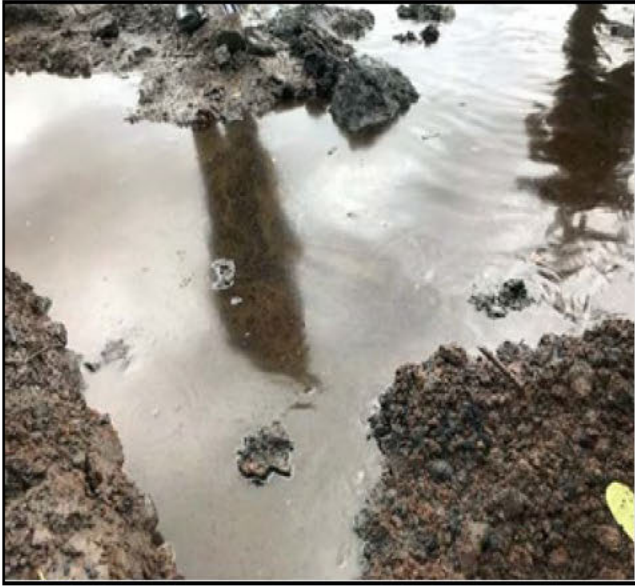
Photolog 154: Facing Down. Large amount of brown oil that was released when removing sediment just north of the outfall at 200' marker. 10/17/19. (START photo IMG_1032)

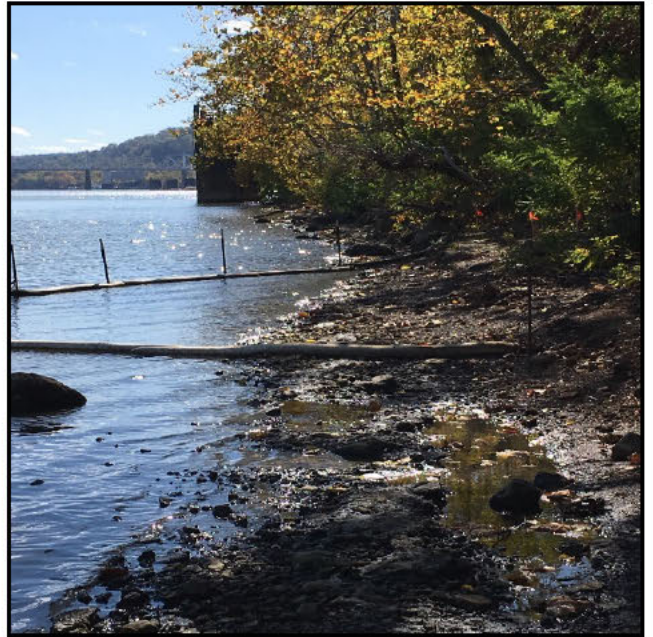
Photolog 155: Cleanup operations in front of the outfall. 10/23/19. (EPA photo IMG_0647)

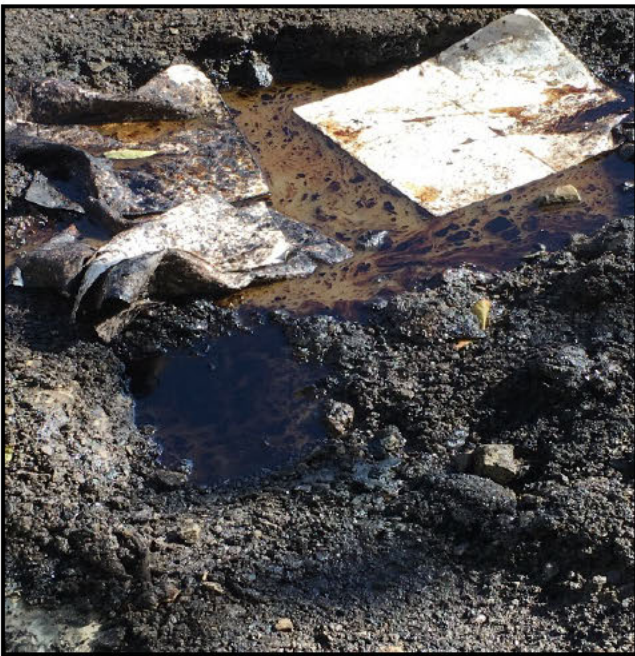
Photolog 156: Oil being removed while working in front of the outfall. 10/23/19. (EPA photo IMG_0637)

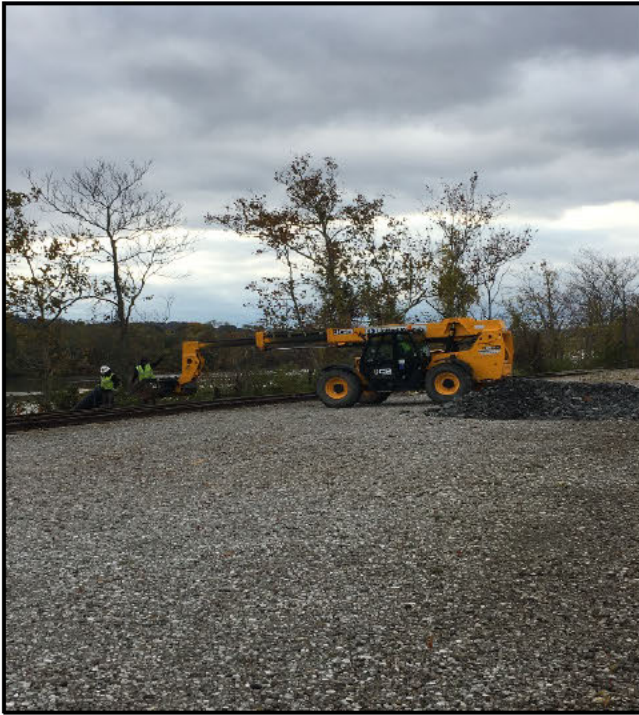
Photolog 158: ERRS crew moving riprap through a chute to the riverbank. Lull being used to move the rock. 11/13/19. (EPA photo IMG_0658)

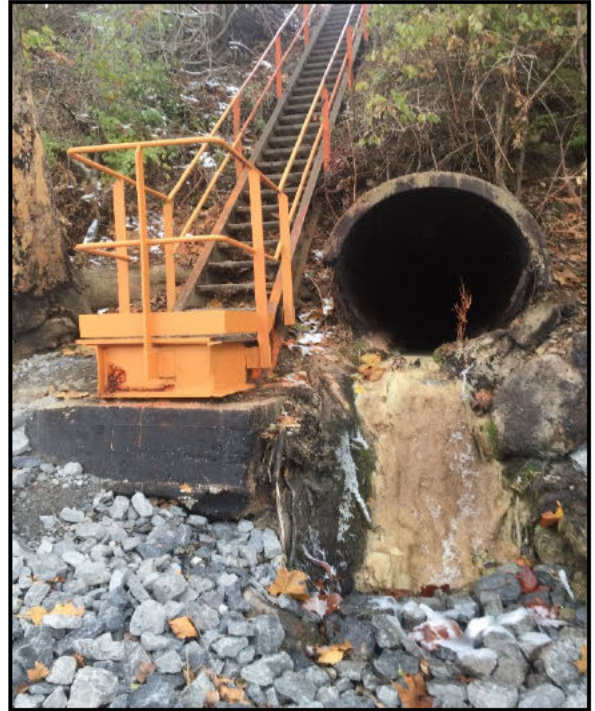
Photolog 159: Cleanup operations complete at outfall. Placement of riprap. Stairs and handrail have also been cleaned. 11/13/19. (EPA photo IMG_0471.jpg)

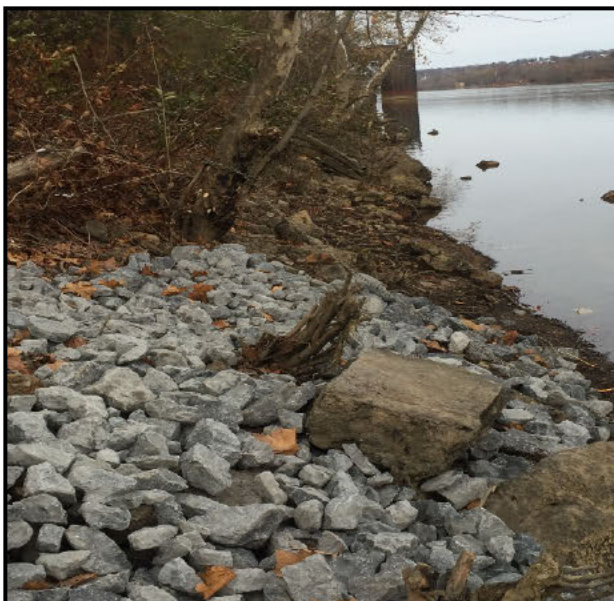
Photolog 160: Cleanup operations complete on the north side of the outfall. Placement of riprap. 11/13/19. (EPA photo IMG_0467.jpg)

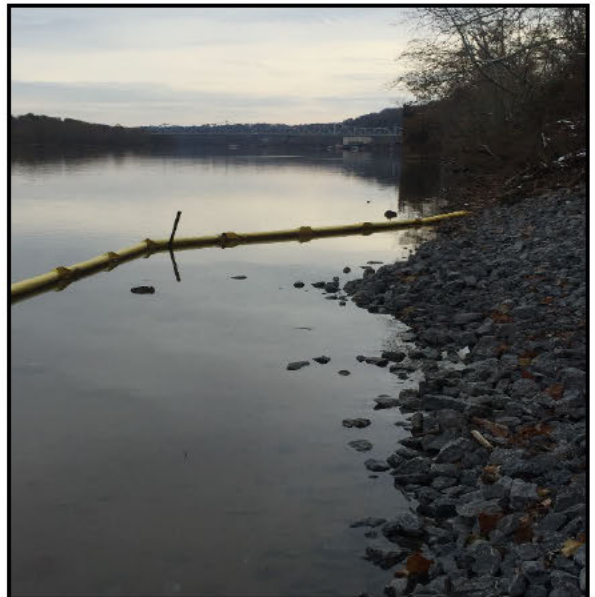
Photolog 161: Cleanup operations complete on the north side of the outfall. Placement of riprap. 11/13/19. (EPA photo IMG_0469.jpg)

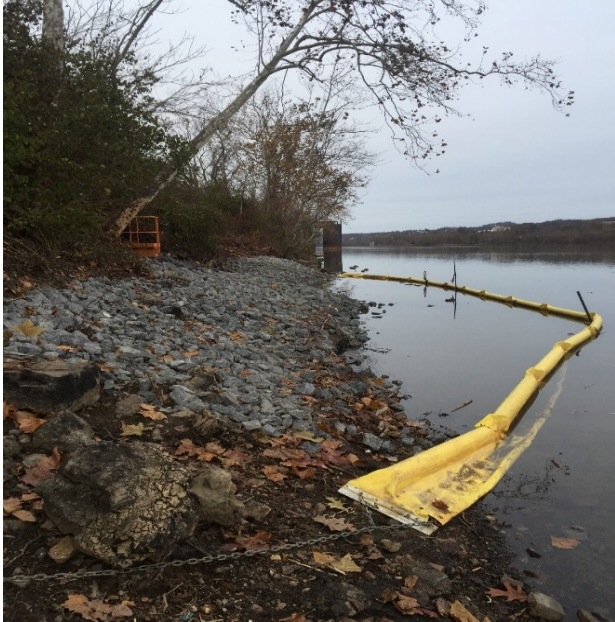
Photolog 162: Facing North. Final site conditions after cleanup operations. 100 ft of containment boom to remain until June 30, 2020. 11/13/19 (EPA photo IMG_0473.jpg)

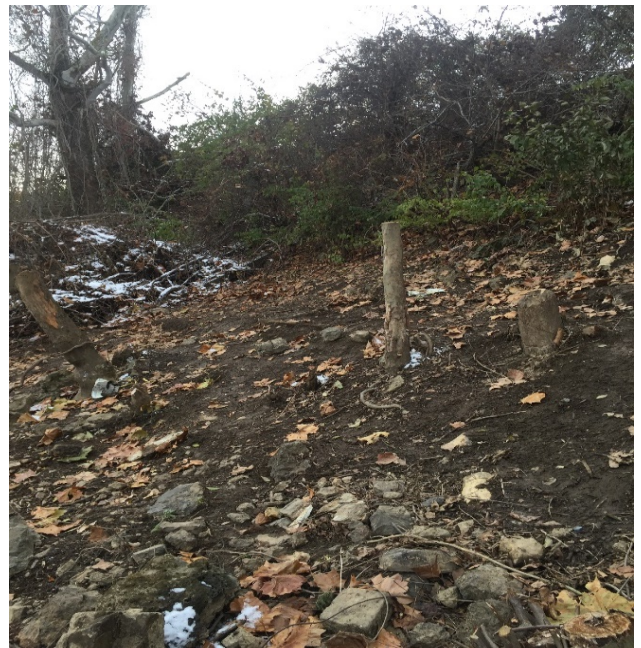
Photolog 165: Staging area on the south side of the outfall after Supersacks removed. 11/13/19. (EPA photo IMG_0476.jpg)

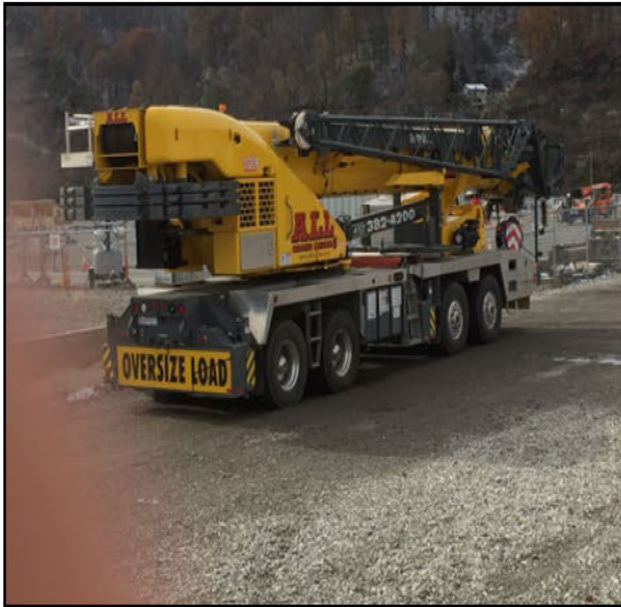
Photolog 166: Crane brought on-site to remove Supersacks from the riverbank to the roll-offs staged at top of the steps. 11/13/19. (EPA photo IMG_0465.jpg)

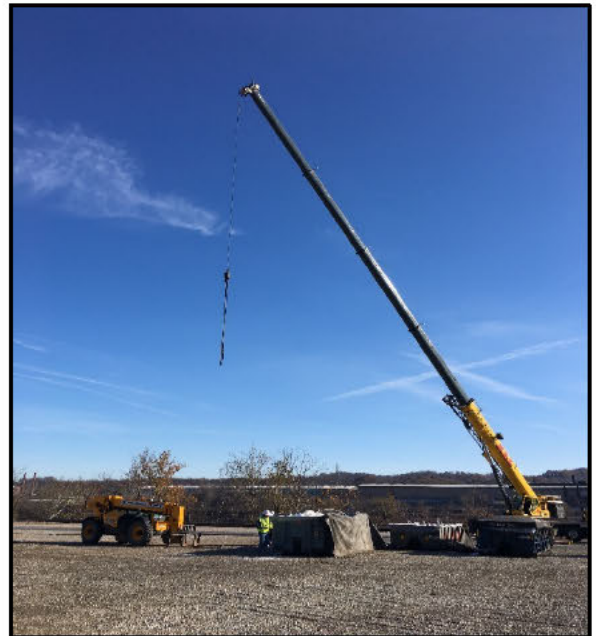
Photolog 167: Layout of crane operations. Crane, roll-off boxes and lull. 11/13/19. (EPA photo IMG_0666.jpg)

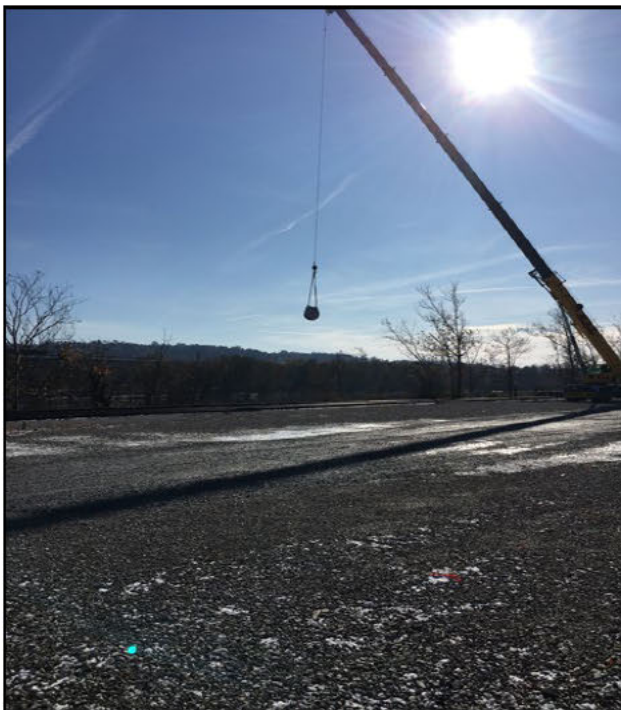
Photolog 168: Crane moving Supersacks from the riverbank to the roll-offs. Supersacks weighed approx. 1500 lbs each. 11/13/19. (EPA photo IMG_0674.jpg)

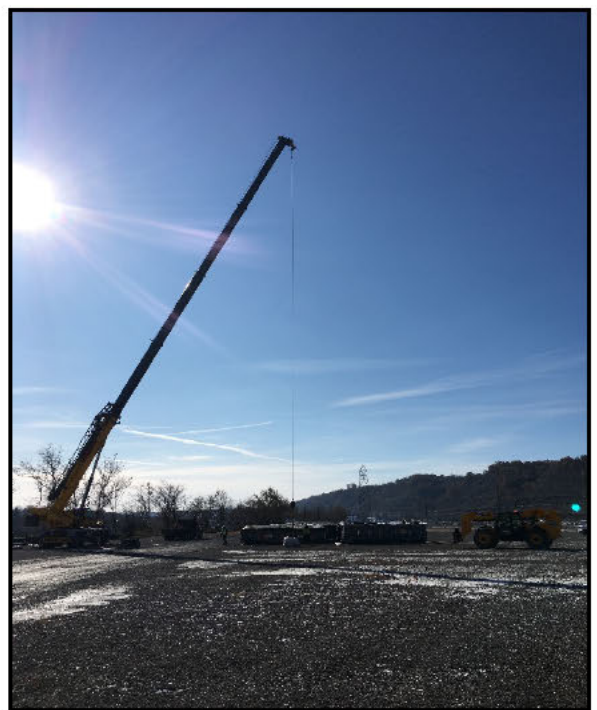
Photolog 169: Crane dropping off Supersack at the roll-off to then be loaded by the lull. 11/13/19. (EPA photo IMG_0676.jpg)

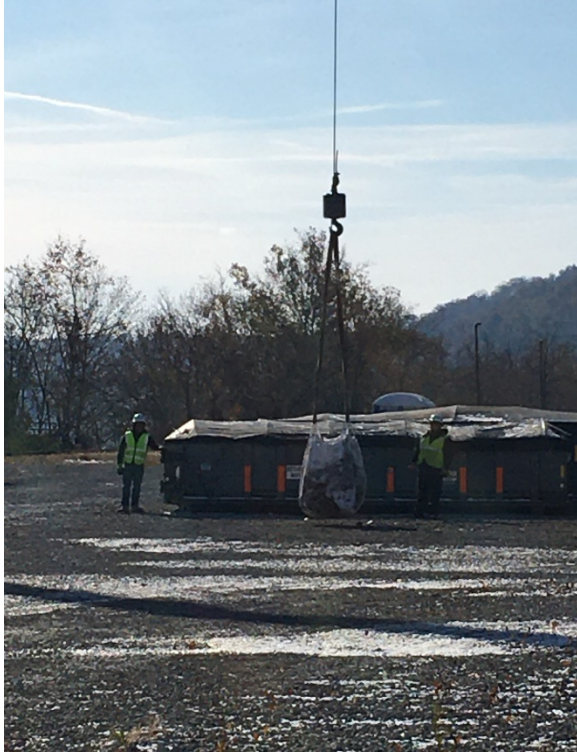
Photolog 170: Closer picture of crane dropping off Supersack at the roll-off to then be loaded by the lull. 11/13/19. (EPA photo IMG_0681.jpg)

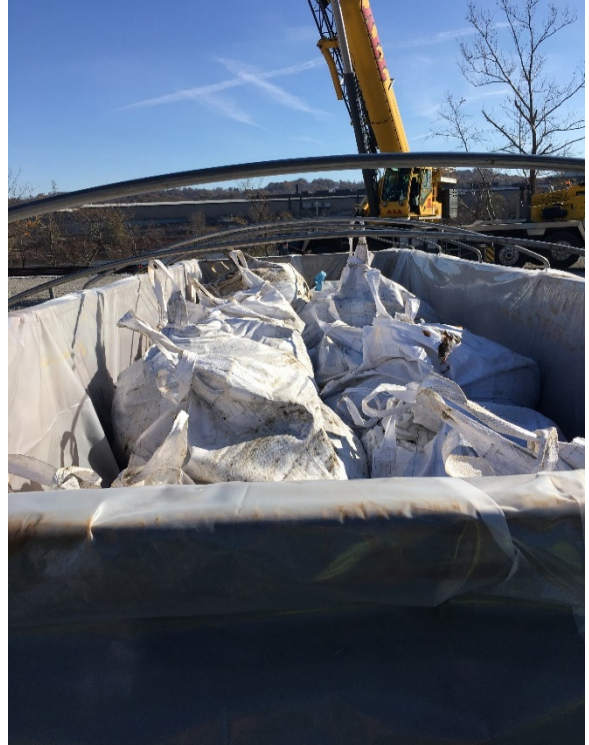
Photolog 171: Supersacks loaded into the roll-off for disposal at landfill. 11/13/19. (EPA photo IMG_0667.jpg)

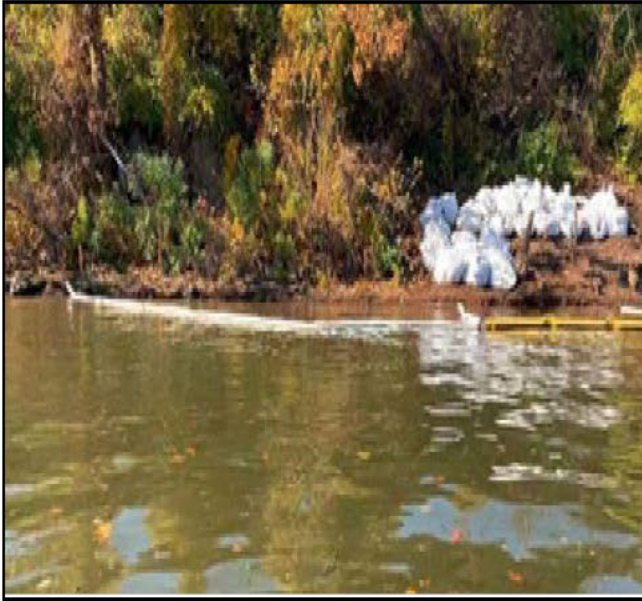
Photolog 172: Facing West. South end of removal area, between markers 290'-360', prior to placing rip-rap material on bank. 10/28/19. (START photo IMG_004.jpg)

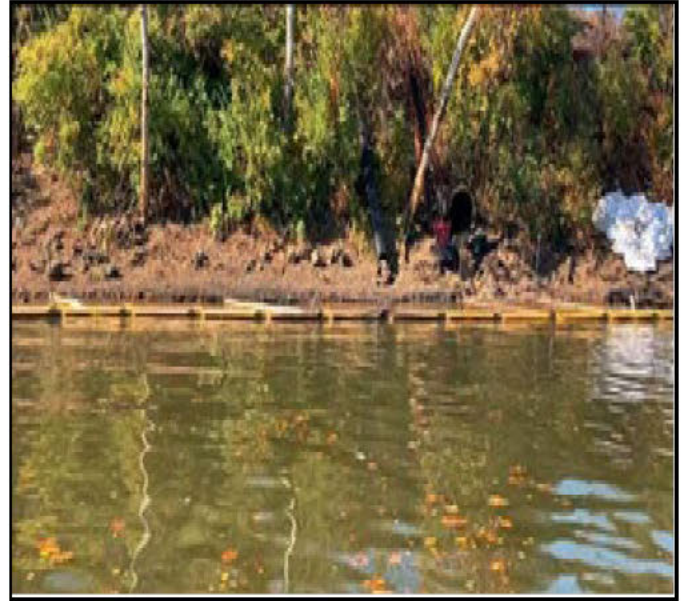
Photolog 173: Facing West. Removal area between markers 180'-290' prior to placing rip-rap material on bank. 10/28/19. (START photo IMG_0046.jpg)

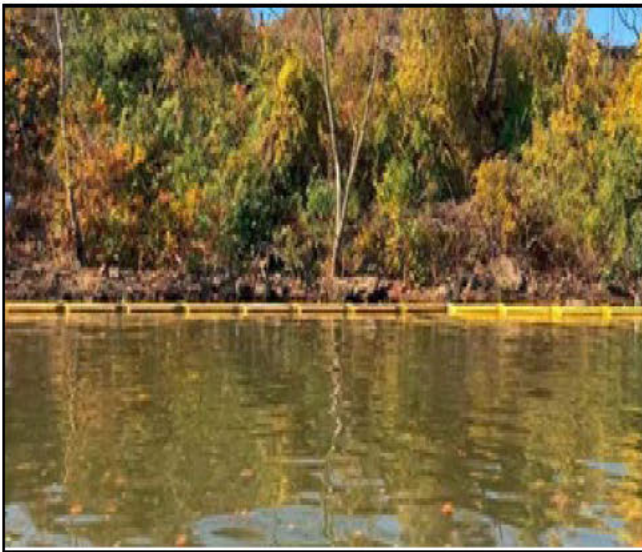
Photolog 174: Facing West. Removal area between markers 80'-170' prior to placing rip-rap material on bank. 10/28/19. (START photo IMG_0048.jpg)

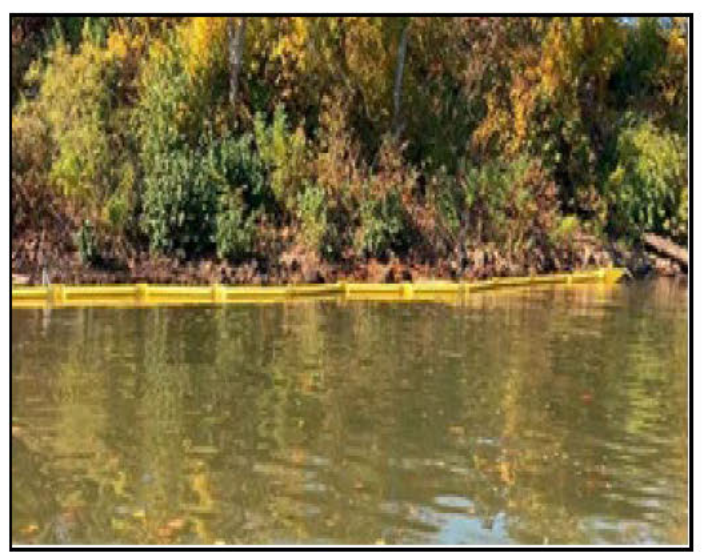
Photolog 175: Facing West. Removal area between markers 0'-80' prior to placing rip-rap material on bank. 10/28/19. (START photo IMG_0049.jpg)

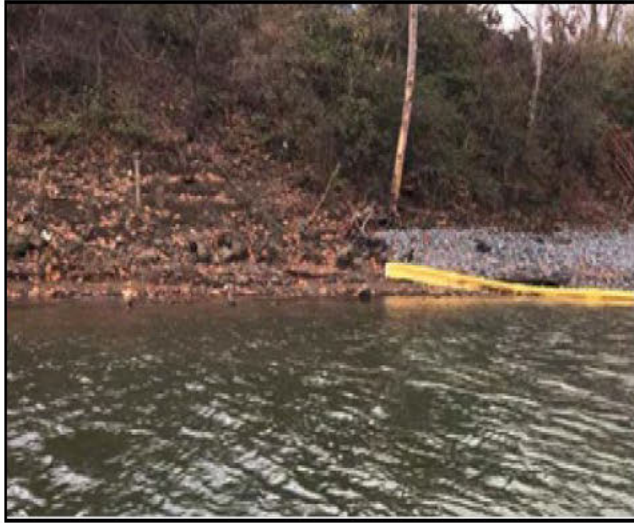
Photolog 176: Facing West. Removal area after completion. South side of outfall. 11/22/19 (START photo IMG_1104.jpg)

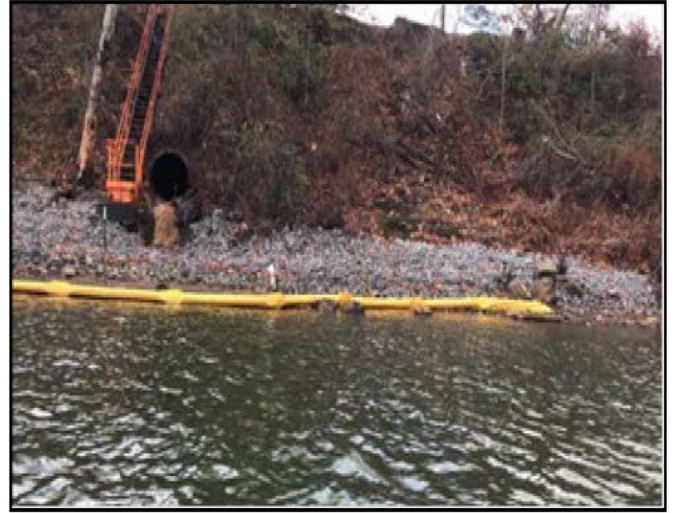
Photolog 177: Facing West. Removal area after completion. North side of outfall. 11/22/19 (START photo IMG_1105.jpg)

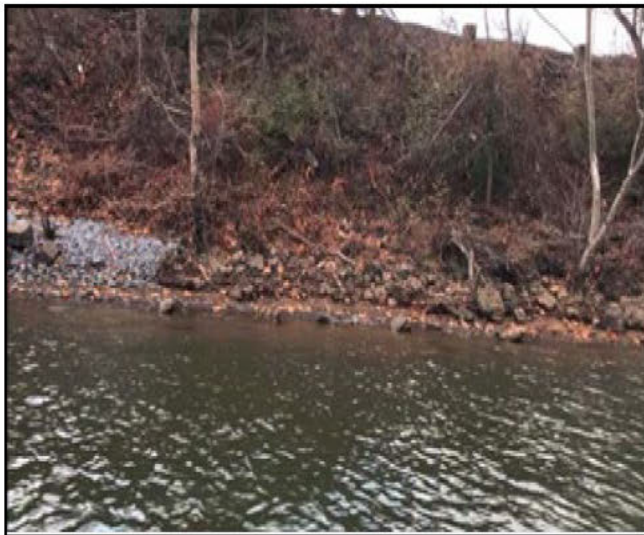
Photolog 178: Facing West. Removal area after completion. North side of outfall 11/22/19 (START photo IMG_1106.jpg)

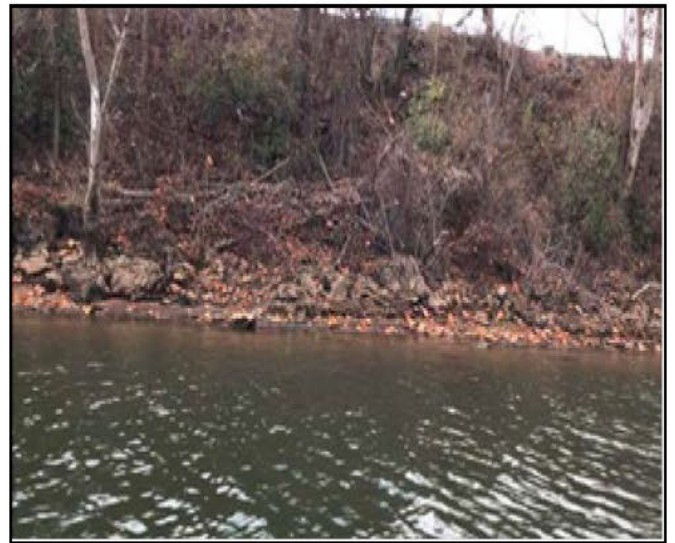
Photolog 179: Facing West. Removal area after completion. 11/22/19 (START photo IMG_1107.jpg)

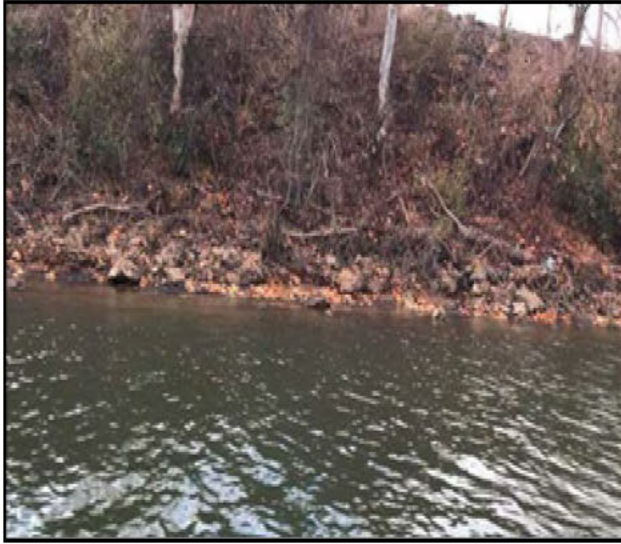
Photolog 180: Facing West. Removal area after completion. 11/22/19 (START photo IMG_1108.jpg)

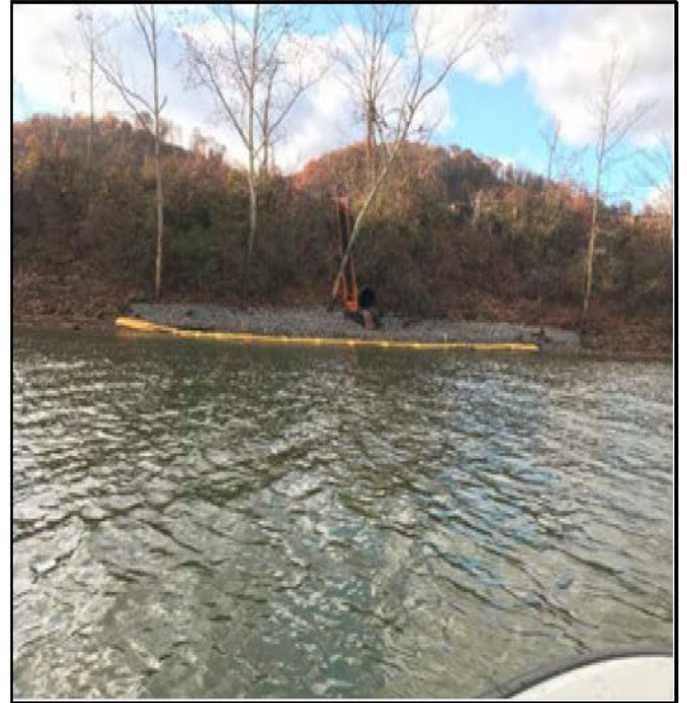
Photolog 180: Facing West. Removal area after completion. 100 feet of containment boom. 11/22/19 (START photo IMG_0013.jpg)

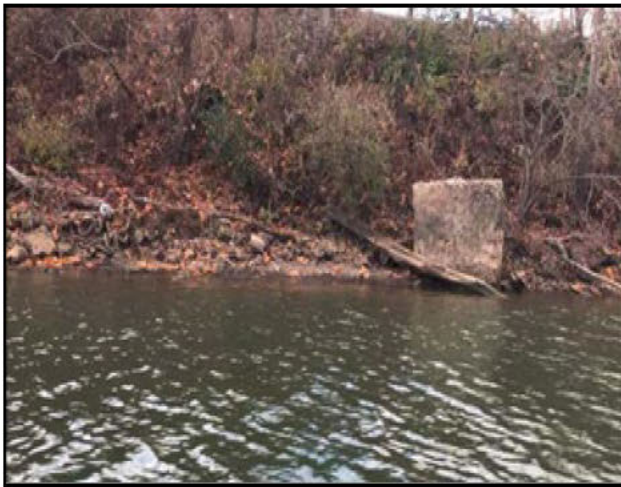
Photolog 182: Facing West. Removal area after completion. 11/22/19 (START photo IMG_1109.jpg)
